Investigation Report
Gasoline on TK38 External Floating Roof

Report Date: 04/07/11

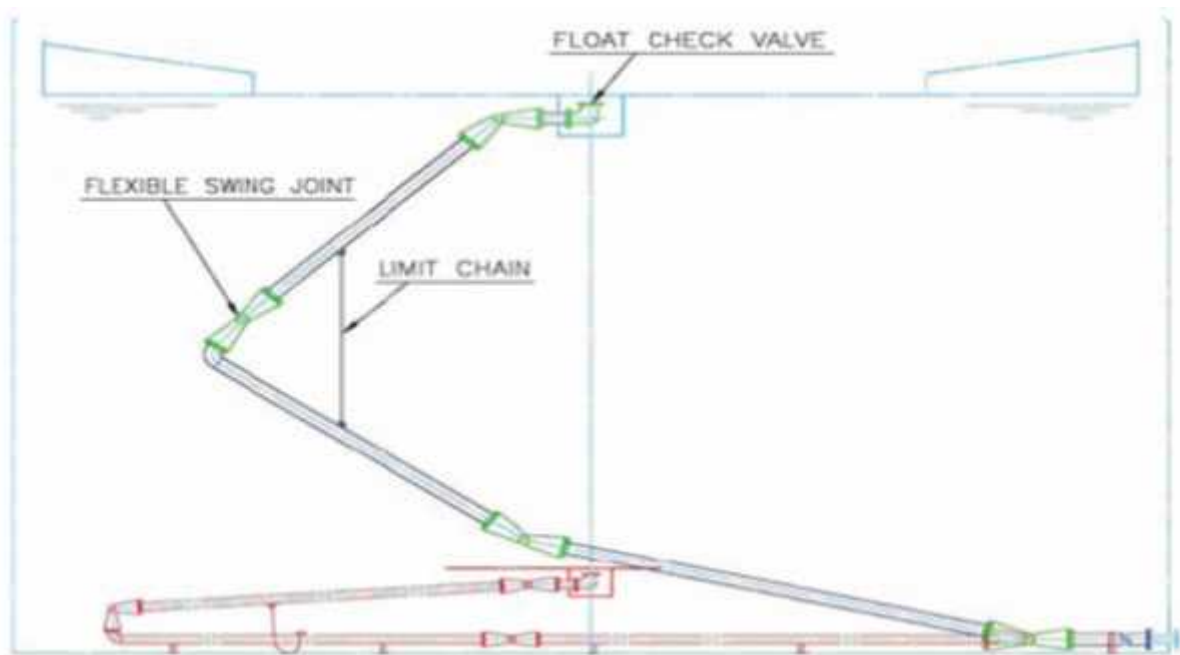
Figure 1: Typical Pivot Master Drain System

The initial thought was that the internal roof drain line had developed a leak allowing gasoline to backflow through the drain line and check valve to the roof. TK38 has a Pivot Master floating roof drain system. See Figure 1.

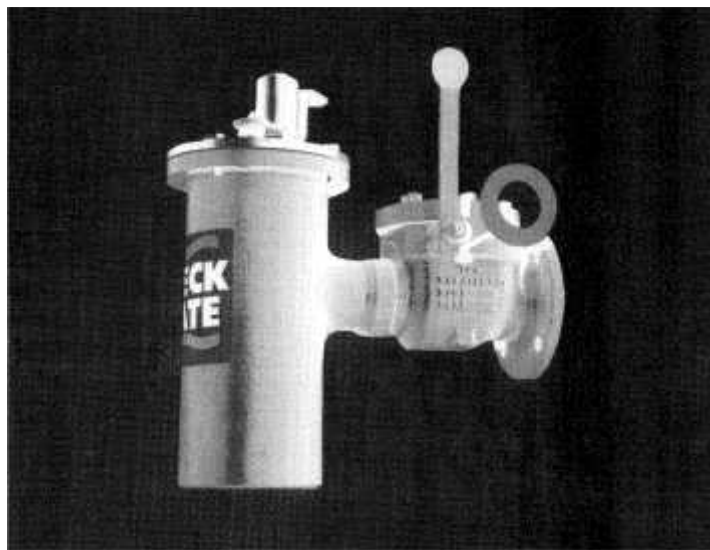
Figure 2: Check Mate Hydrocarbon Sensing Valve Picture

The hydrocarbon sensing element in the Check Mate valve was found to be coated with green algae. The flange face and check valve seating surface were also found to be corroded beyond repair.

Although it was not a contributing factor to this incident, the TK38 Check Mate Hydrocarbon Sensing Valve was in poor condition. The styrofoam hydrocarbon sensing element was encased in green algae that may have been impenetrable to gasoline. Thus, the Check Mate Valve may have failed to close had there been a leak in the TK38 internal Pivot Master drain system.

1. Create a maintenance PM work order to do yearly preventative maintenance of all Check Mate Hydrocarbon Sensing Valves as recommended by manufacturer. PM would include replacement of the hydrocarbon sensing element as well as cleaning and inspection of the actuator mechanism and check valve internals. – COMPLETE

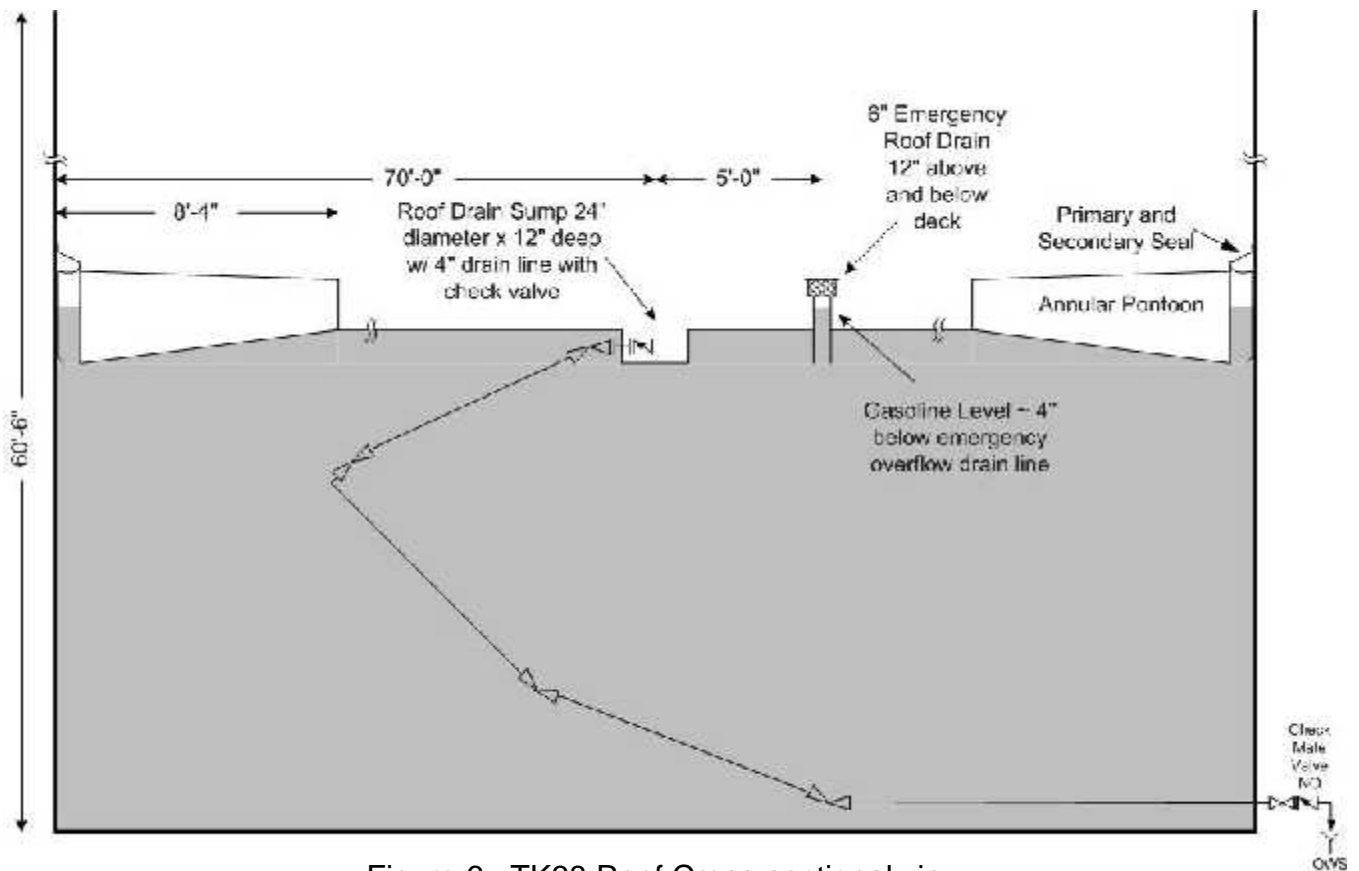
Figure 6: TK38 Roof Cross-sectional view

TK38 also has a 6" diameter emergency overflow drain nozzle on the roof. This is a vertical nozzle through the roof deck located 5 feet from the center of the roof. This nozzle extends 12" above and 12" below the roof deck. A 10" diameter wire mesh screen with a top cover sits on top of the nozzle.

According to PEI, the liquid level was observed to be about 4" below the inlet to the emergency overflow drain line after all the liquid was removed from TK38 roof.

1. Conduct a risk analysis to determine if roof emergency overflow drains can be removed from single deck floating roof tanks. Review should involve technical resources such as a tank engineer (e.g. from TANCO) or Shell P&T tank expert.

If the risk analysis concludes that emergency overflow drains are not required or recommended on single deck floating roof tanks, consider blinding/capping them off or plugging them with a plumbers plug and also creating a CAIR to remove them and install a lap patch as the tanks come out of service for turnaround.

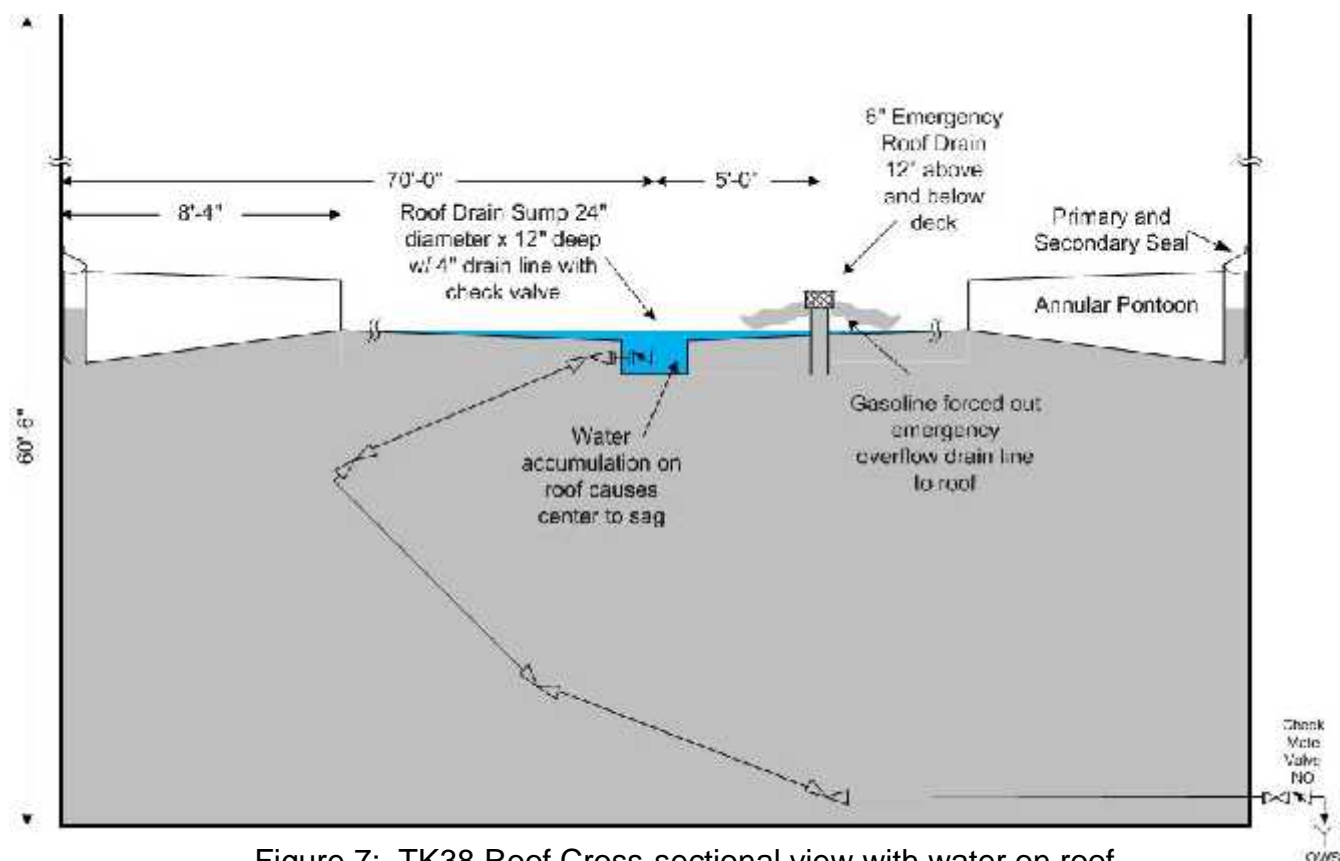
Figure 7: TK38 Roof Cross-sectional view with water on roof

The cause of this incident was the accumulation of rain water on TK38 which added weight to the roof causing it to flex in the center and sink lower into the gasoline volume within the tank and force gasoline onto the roof through the emergency overflow drain line. Refer to Figure 7.

The cause of the rain water accumulating on the roof was due to an obstructed roof drain line. The nature of the obstruction could not be positively determined, but is believed to be due to either accumulation of debris (sediment/moss/algae) in the roof drain sump or due to a sticking roof drain check valve. Given the amount debris removed from the drain line with the vacuum truck and the subsequent amount of debris removed by hand, it is likely that this was the most probable cause. The inspection of the check valve revealed no operational problems.

The emergency overflow drain line also provided the route for gasoline to flow onto TK38 roof.

API Standard 650 (Welded Steel Tanks for Oil Storage – Eleventh Edition, June 2007) now prohibits emergency overflow drains on single deck pontoon roofs for new tank construction or repairs to existing tanks. This is because the product level in the tank is always higher than the rain water level in the center of the deck, which would cause the product to discharge through the drain onto the roof rather than allow rain water to drain into the tank. Note: PEI follows API 653 (Tank Inspection, Repair, Alteration, and Reconstruction) for inspection and repair standards. If repairs are required, this standard refers back to API 650.
